**FINAL REPORT
CLEAN-UP OF
PROPYLENE OXIDE SPILL**

REN PLASTICS, INC.

FINAL REPORT
CLEANUP OF PROPYLENE OXIDE SPILL
AT REN PLASTICS, INC.

Snell Environmental Group, Inc.
1120 May Street
Lansing, Michigan 48906

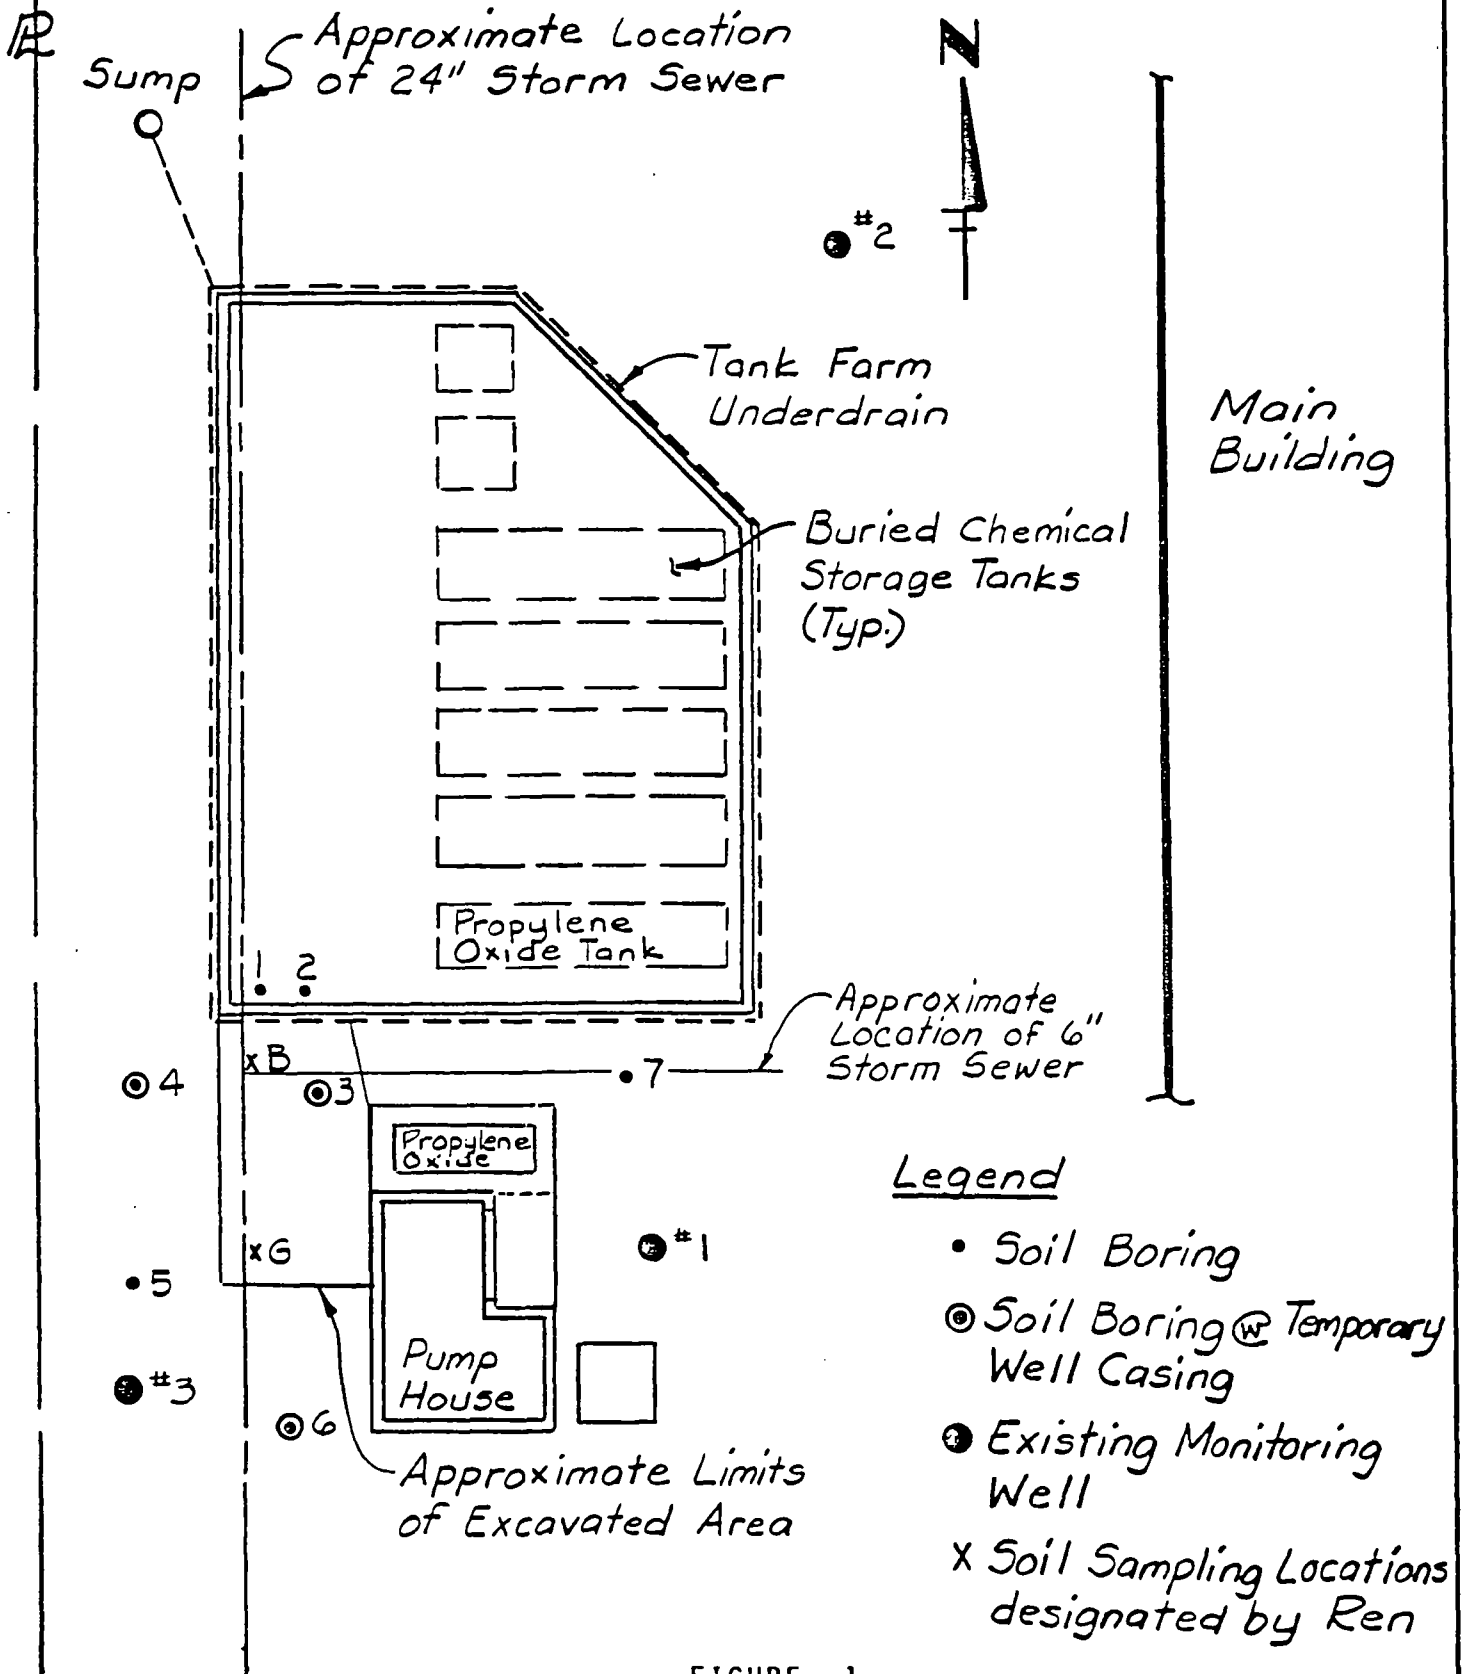
FIGURE 1

On April 4, 1985, Ren Plastics, Inc. (RPI) requested Snell Environmental Group, Inc. (SEG) to investigate a leak of propylene oxide at their Dawn Avenue facility. SEG was also requested to manage any subsequent cleanup activities. The propylene oxide used by RPI is a liquid stored in two underground tanks located as indicated on the attached site plan, Figure 1.

Prior to SEG's involvement, RPI personnel had conducted preliminary investigations and had excavated a trench exposing the chemical supply line from the pumphouse to the main building. Testing of soil samples obtained at sites in the excavation, designated on Figure 1 as B and G, indicated high concentrations of the contaminant. All laboratory analyses of the soil and water samples from this overall investigation were conducted by RPI and are included in Attachment No. 1.

SEG, utilizing Keck Consulting Services, conducted an investigation to delineate the movement of the leaked contaminant. Accordingly, soil borings 1 through 7 were located as shown on the site plan. Soil borings 1, 2 and 3 were hand borings and could not be advanced significantly below the water table due to the soil collapsing around the hand auger causing some uncertainty about the representative nature of the soil sample. Utilizing a truck-mounted drilling rig, soil samples were acquired in borings 4, 5, 6, and 7 at 2-foot intervals for laboratory analyses. Temporary well casings were installed in borings 3, 4, and 6 to facilitate obtaining representative groundwater samples. A soil sample at the base of the pumphouse foundation next to the buried tank was also acquired by hand auger.

Air testing of the chemical supply line was carried out and it was determined by visual observation of the line under water that the line was leaking at approximately sample Location B.

The laboratory analyses from the soil and groundwater testing showed that contamination was present in the excavated area. The highest concentrations were found in Location B (north pit). High concentrations of the contaminant were found at Location G (south pit) and in soil boring 3, both water and soil samples. The contaminant was also detected in the storm sewer discharge to the river. However, soil and groundwater samples from borings 1, 2, 4, 5, 6, and 7 showed no detectable levels of contaminants. The monitoring well installed next to the storm sewer, with the screen set at the same level as the sewer, was a dry well (as of April 12, 1985). During the drilling of the well, no stone (sand) bedding was noted to be around the pipe.

Based upon the laboratory results and our interpretation of the various soil data, we conclude that the material that leaked from the pipe has been laterally contained within a maximum area outlined by borings 1, 2, 4, 5, 6, and 7. This lateral containment is consistent with the hydrogeological report that the material above the clay till is of low permeability and does not transmit water readily. Because of the presence of propylene oxide in the storm sewer discharge, we concluded that the material from the leak was moving vertically to the storm sewers and infiltrating into the pipes by means of cracks or leaking pipe joints.

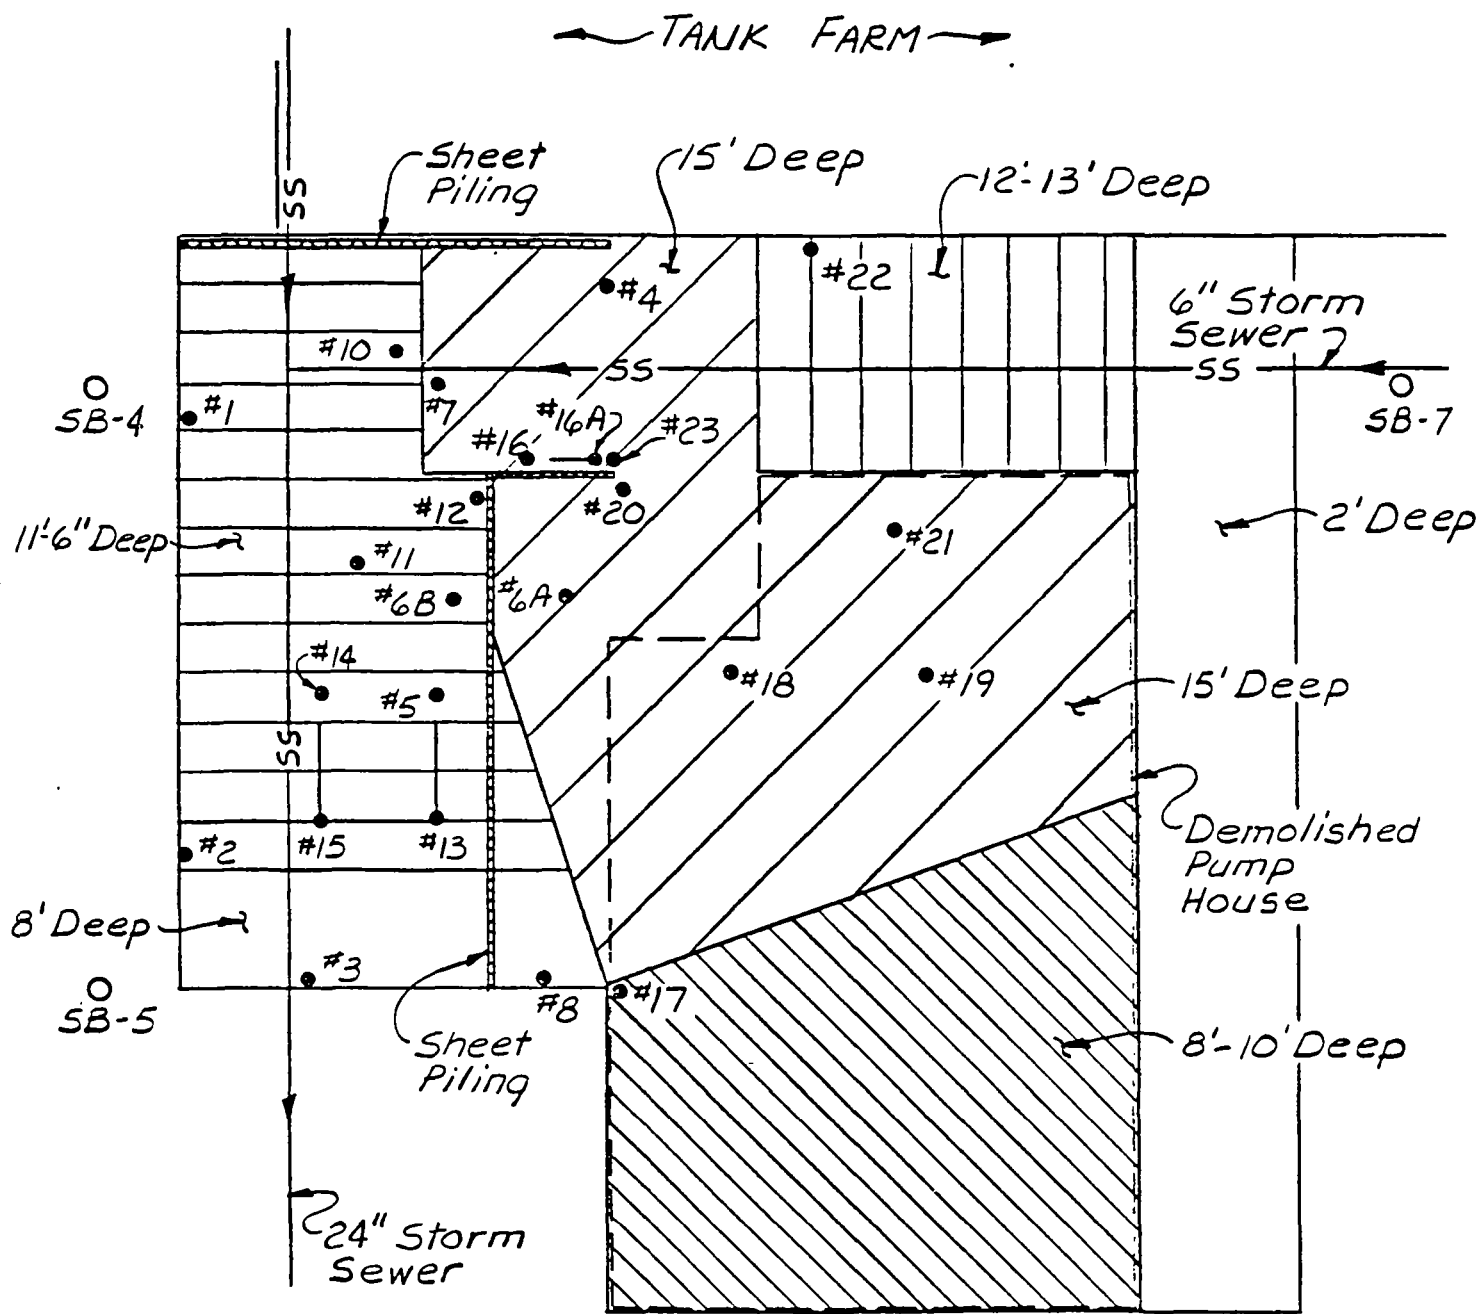
FIGURE 2
EXCAVATION PLAN & SAMPLING SITES

Sample points #7 at 11'-6" deep, #14 at 11'-6" deep, #15 at 8' deep, #13 at 8' deep and #1 and #2 at 4'-5' deep showed non-detectable levels of the contaminant, confirming that all contamination in that area had been removed.

Samples obtained next to and under the pumphouse foundation, #16 and the 6A series, showed contamination under the building. The decision was made to remove the building and the soil under the foundation. A similar approach was utilized to determine the effectiveness of the cleanup. Consequently, sample points #8, #17, #19, #20 and #22 were analyzed and show that the contaminant was non-detectable.

The work of cleaning up the contaminated area was awarded to Granger Excavating Company, Lansing, Michigan. Because contamination had been identified at a depth below the foundations of the tank farm retaining wall and the pumphouse, Granger installed sheet piling, as indicated on the attached sketch, Figure 2, to prevent their collapse. Excavation was initiated in the area of highest contaminant concentrations. As material was excavated and the underlying clay till was exposed, soil samples were taken both from the till surface and from the exposed sidewalls. Additional samples were obtained from beneath the pumphouse foundation. The attached sketch, Figure 2, shows the areas that were excavated, the varying depths of excavation and the sampling locations.
